# Management of PT bridges

Management of  
post-tensioned bridges

This state-of-the-art-report was drafted by Working Party 1.1.5 - "Management of Post-tensioned Concrete Bridges" within the *fib* Task Group 1.1 "Bridges".

# WHAT IS POST-TENSIONING

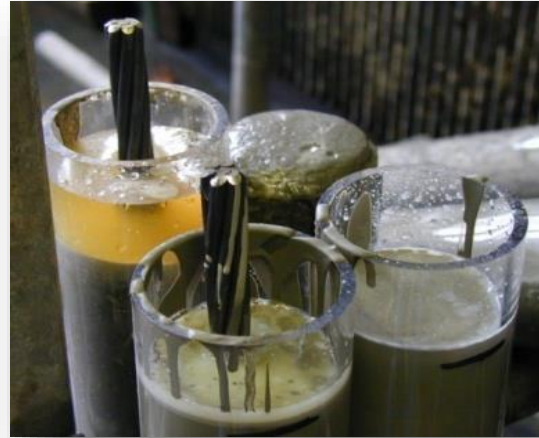
VSL tests of grout mix

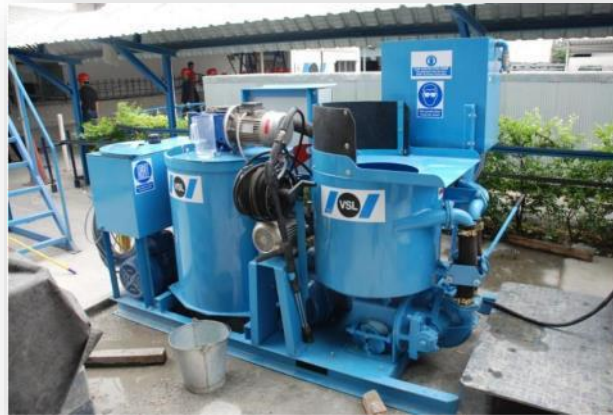
VSL grout mixer

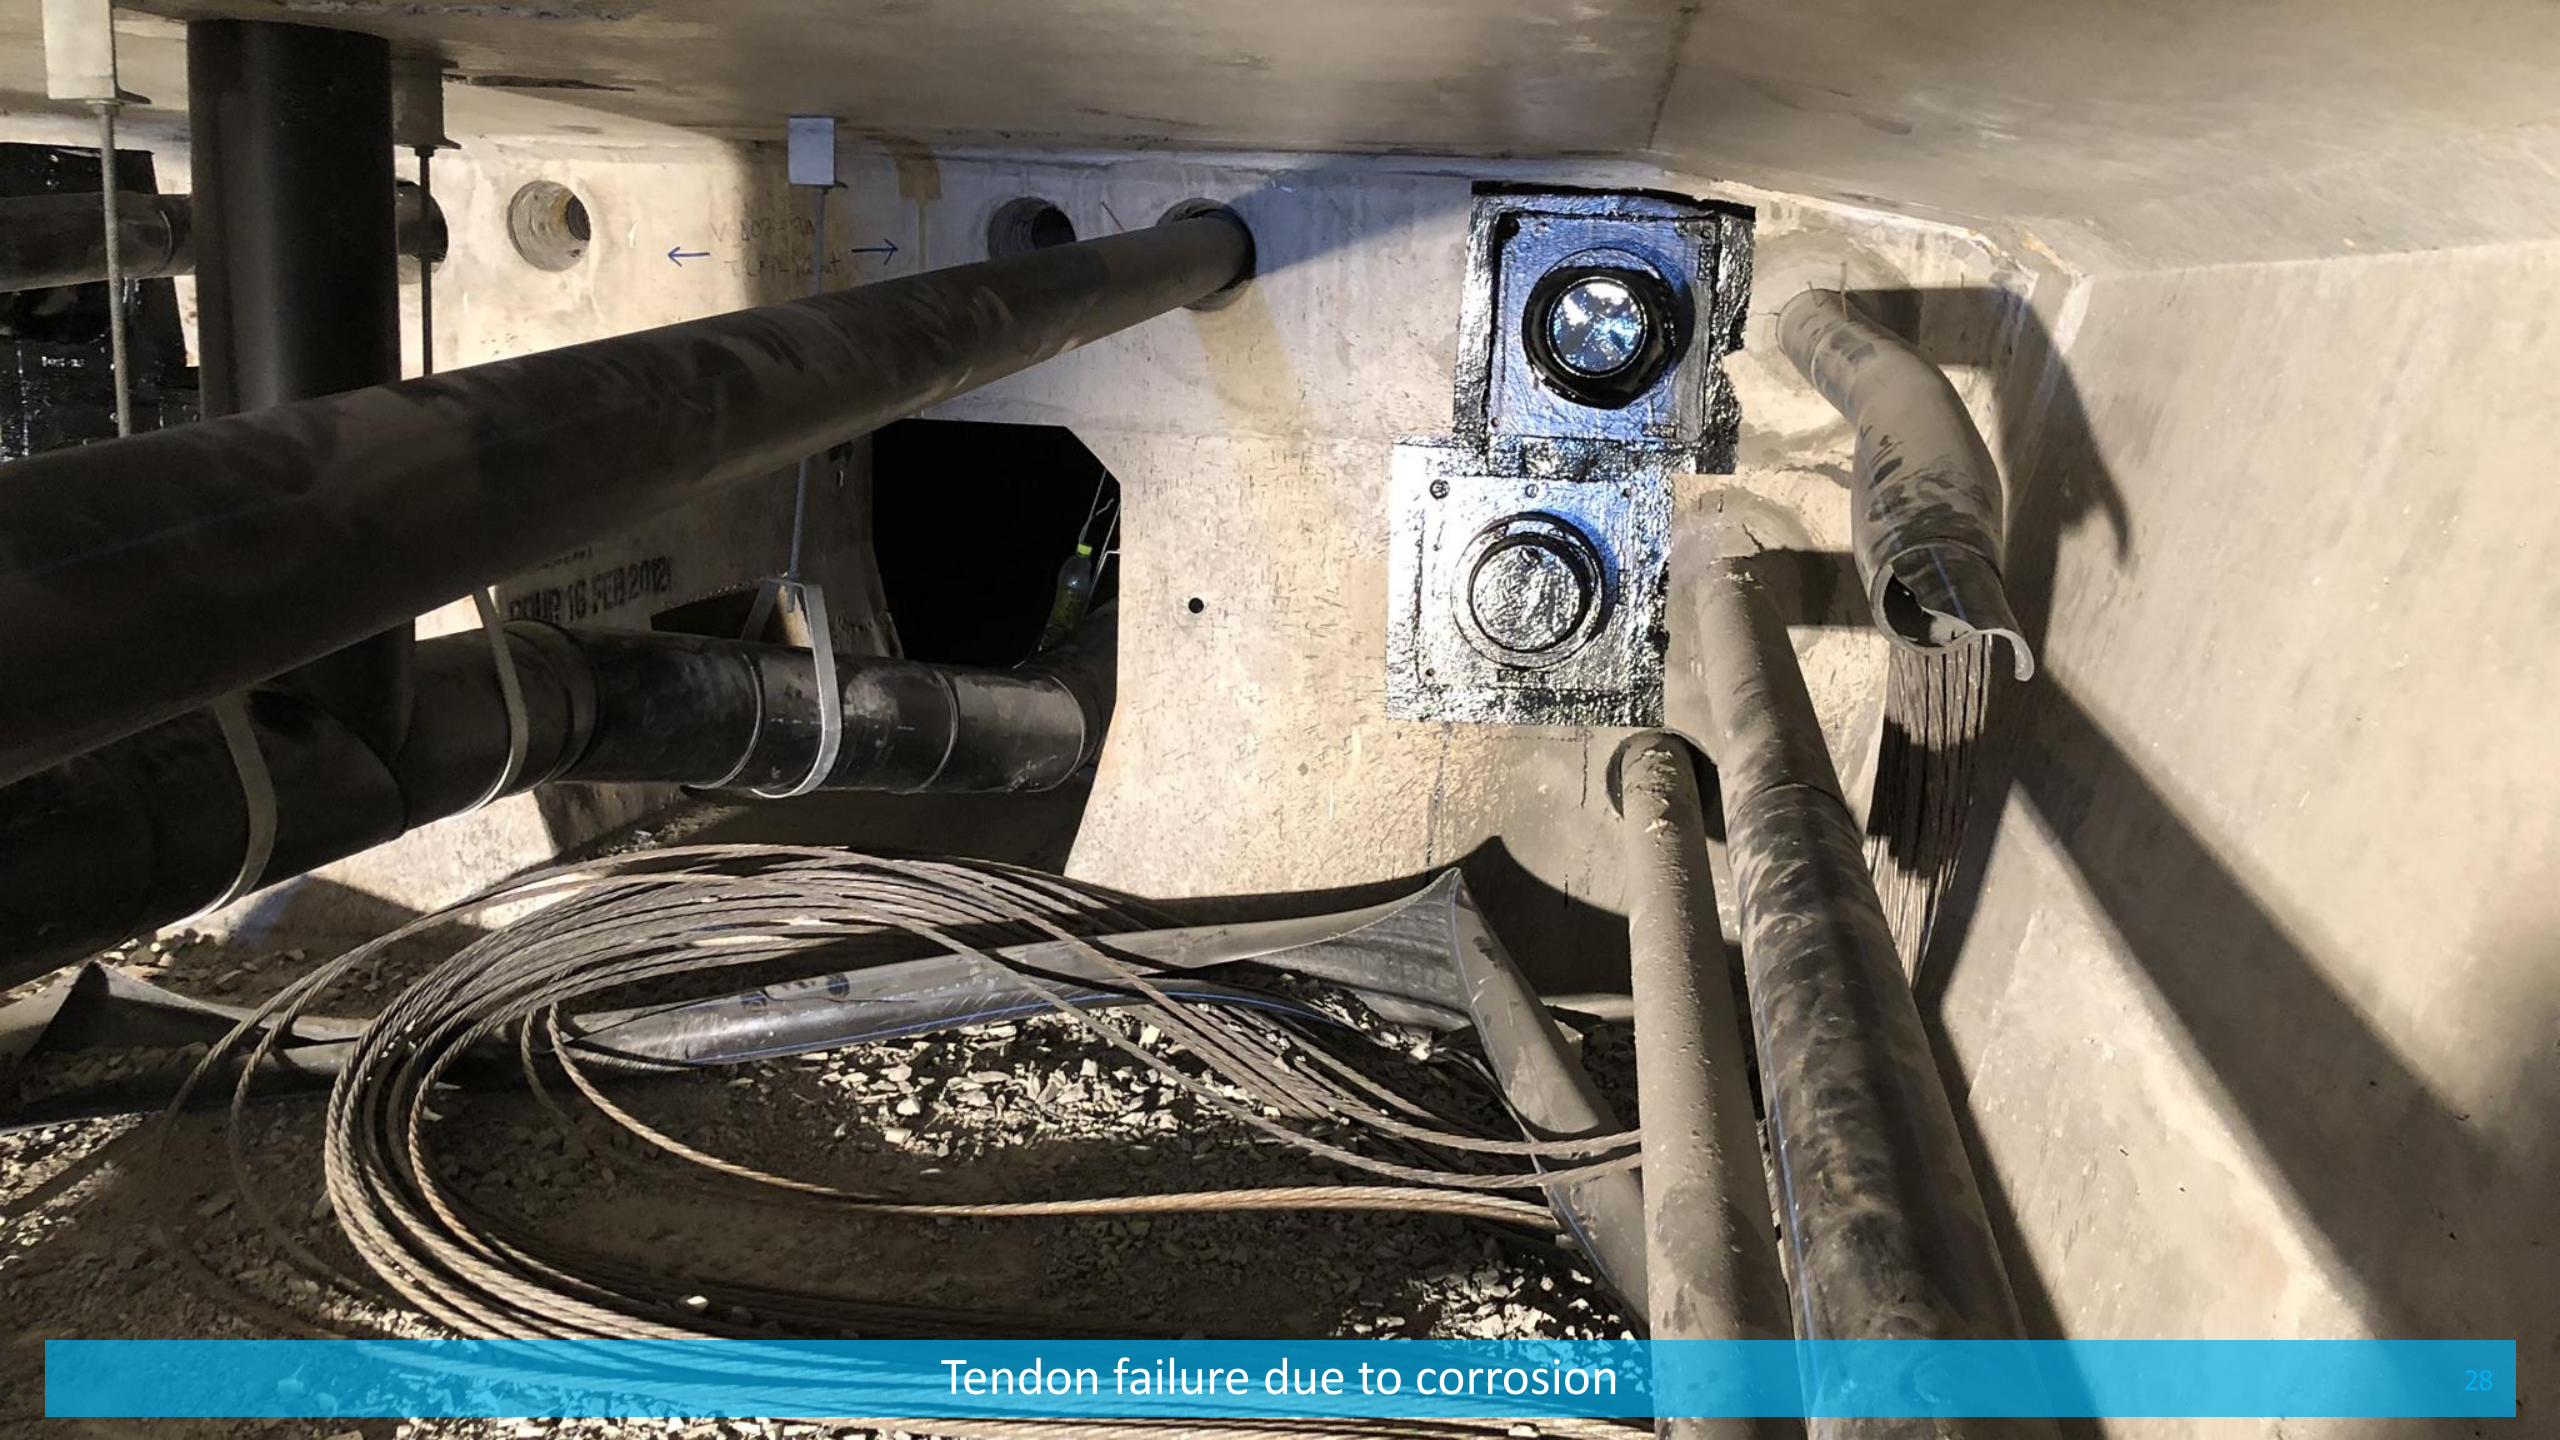
Tendon failure due to corrosion

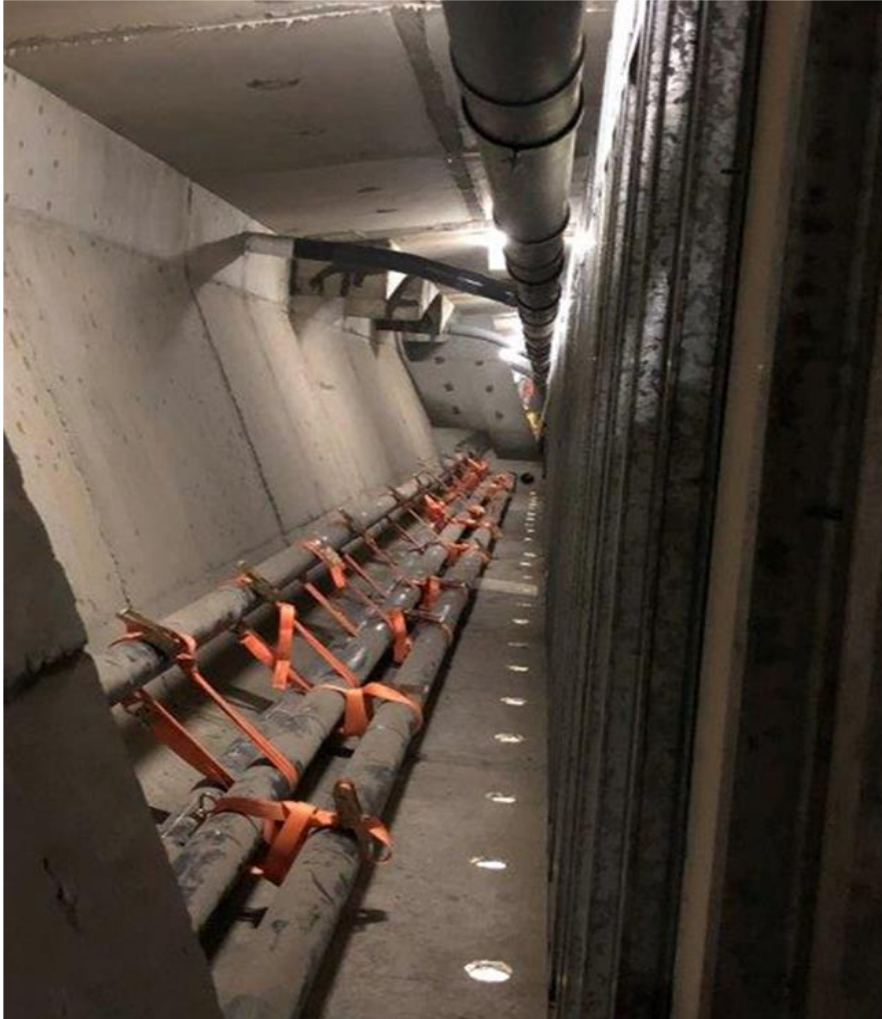
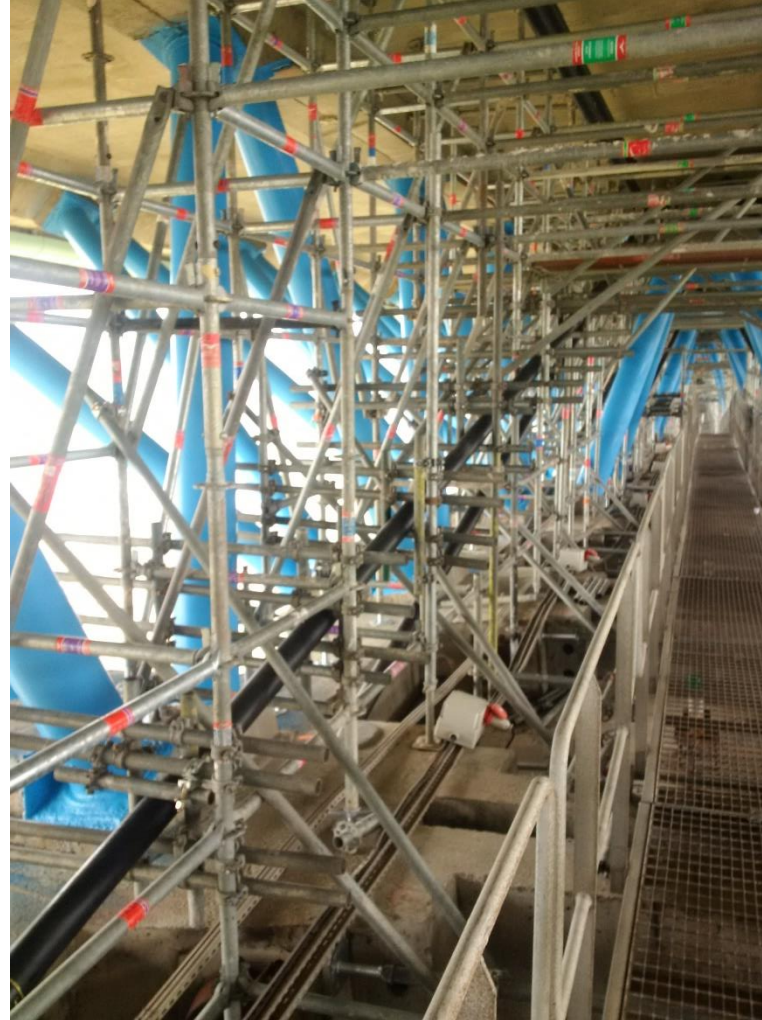
# CONTROLLING ACCIDENTAL TENDON RELEASE

- Wrapping has established itself as 'standard' method, possibly combined with shock absorbers behind anchorages
- Alternative solutions using scaffold containments are expensive and difficult to deploy
- Need to design by simulation of dynamic behaviour
- Risk management strategy based on short intervention times

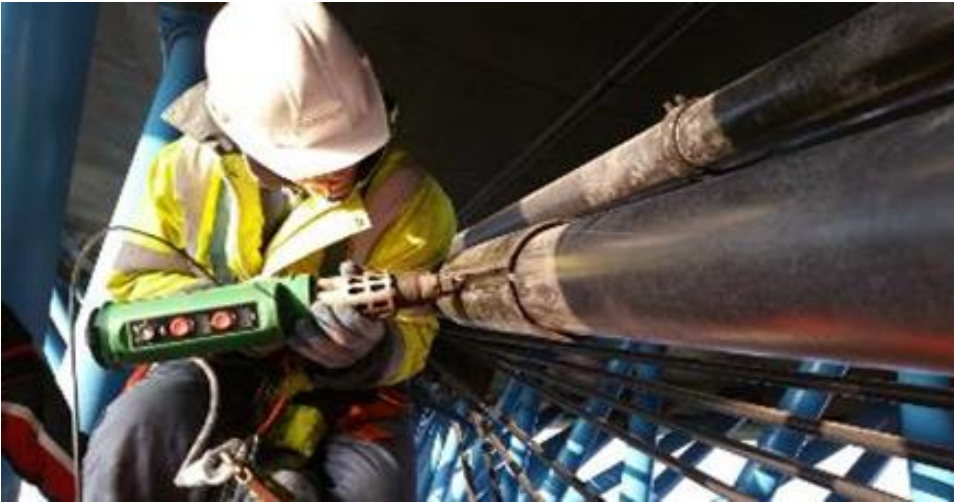
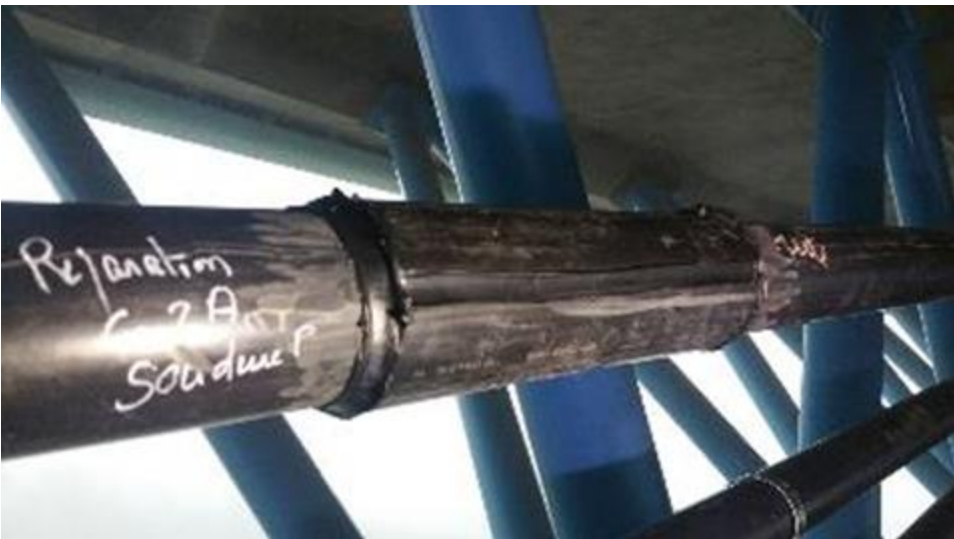
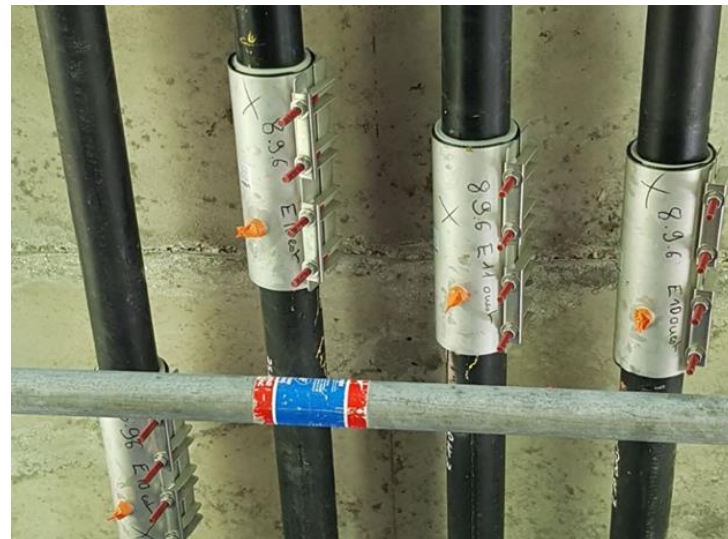
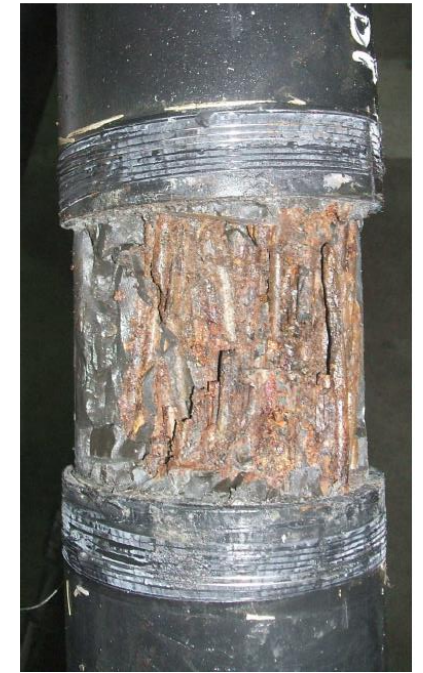
# DUCT REPAIR

- Repair by HDPE half-shell welded in-situ
- Needs to be leak tight, durable and avoid ingress of moisture and pollutants
- Where no access, metallic half shells with sealing assembly to be used
- Treatment of grout / strand prior sealing depending on condition
- Injection of gap with wax or grout
