# **Structural capacity assessment of PC members subjected to different corrosion-induced damage scenarios**

**Beatrice Belletti, University of Parma, Italy**

*Presentation based on the Key – note presented at the fib Symposium 2025 in Antibes*

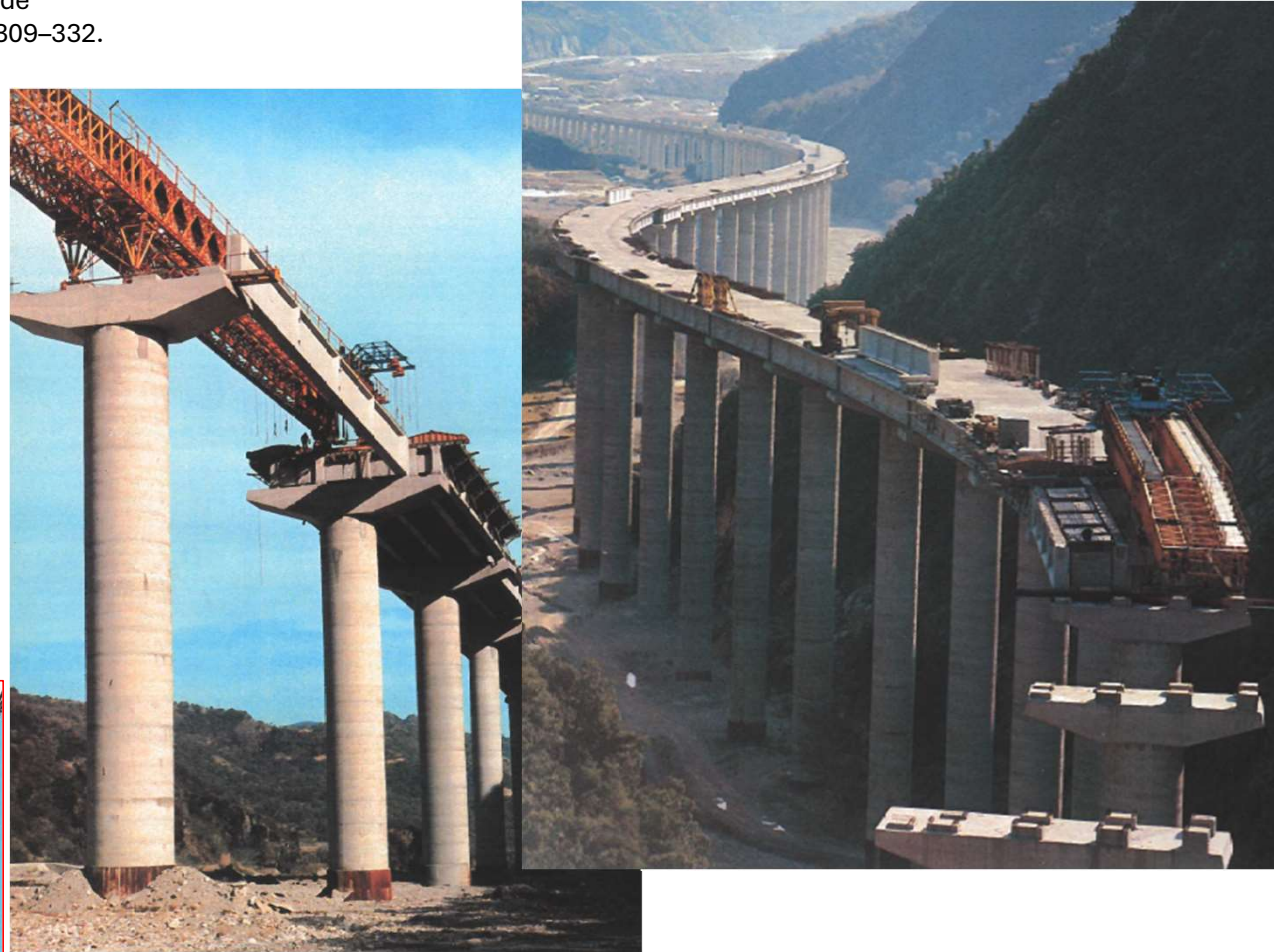
Viaduct designed in 1976 and executed in 1988

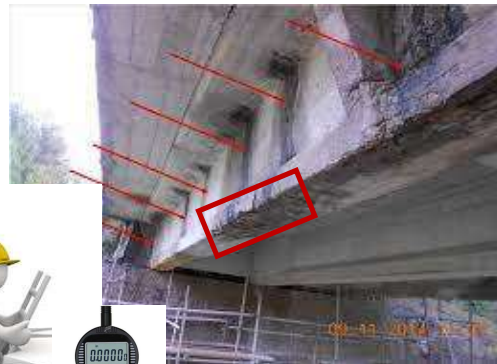
### In-situ Inspection

by using a  
pit depth gauge instrument

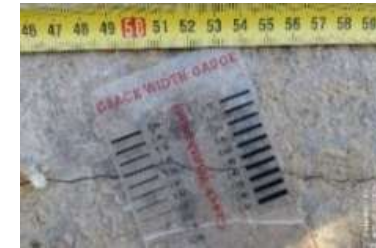
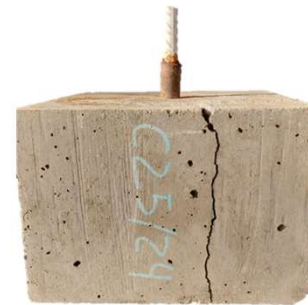
## “INDIRECT MEASURE OF THE DEFECT” crack width/superficial deterioration

Starting from the observation of the superficial deterioration, some assumptions about the pit depth values have been made

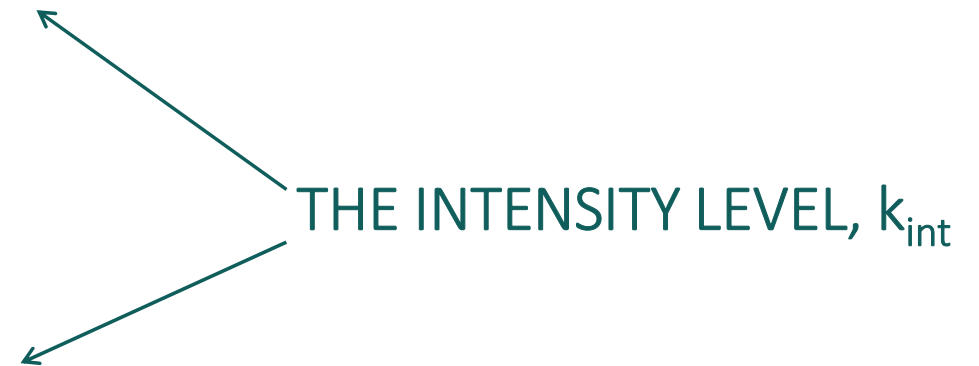
**The first approach to define the intensity level,  $k_{\text{int},1}$**

**The second approach to define the intensity level,  $k_{\text{int},2}$**

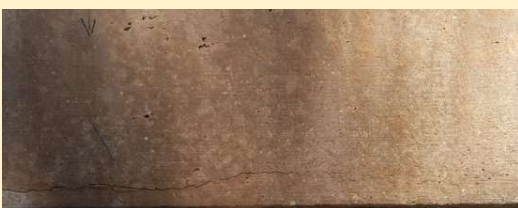
| <p><b>0 - 1:</b> Initiation phase</p> | <p><b>1 - 2:</b> Visible splitting cracks</p> <p>Assumed value for the example:<br/><math>w = 0.3</math> mm</p> <p><b>A range of value could be selected</b></p> | <p><b>2 - 3:</b> concrete cover spalling and visible section loss in corroded wires</p> <p>Assumed value for the example:<br/><math>w = 1.5</math> mm</p> <p><b>A range of value could be selected</b></p> | <p><b>3 - 4:</b> 100% cross-section loss of some wires in strands</p> <p>Assumed value for the example:<br/>2 wires having 100 % section loss</p> <p><b>selected quite arbitrarily</b></p> |

For low and medium intensity levels, the relation between corrosion in strands and crack opening width proposed by Ahmed et al. has been modified to be directly implemented in SCPS model.

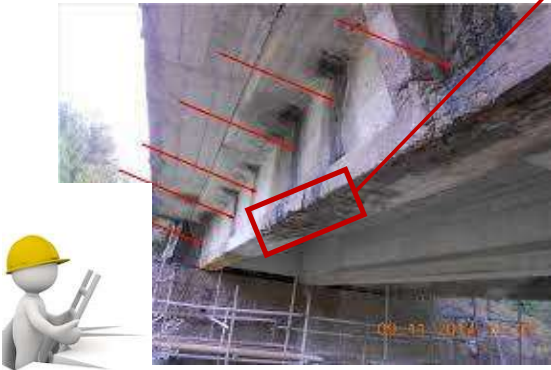
In-situ Inspection

- The superficial defect (ex crack opening) can be measured with different tools having different tolerances and levels of accuracy
- The crack opening values adopted to describe different propagation phases need a statistical distribution, not considered in this example
